DOE/ID-11011

***The 2002 Institutional Controls Inspection,
Environmental Monitoring, and Site
Maintenance Report for Waste Area Group 1***

July 2002

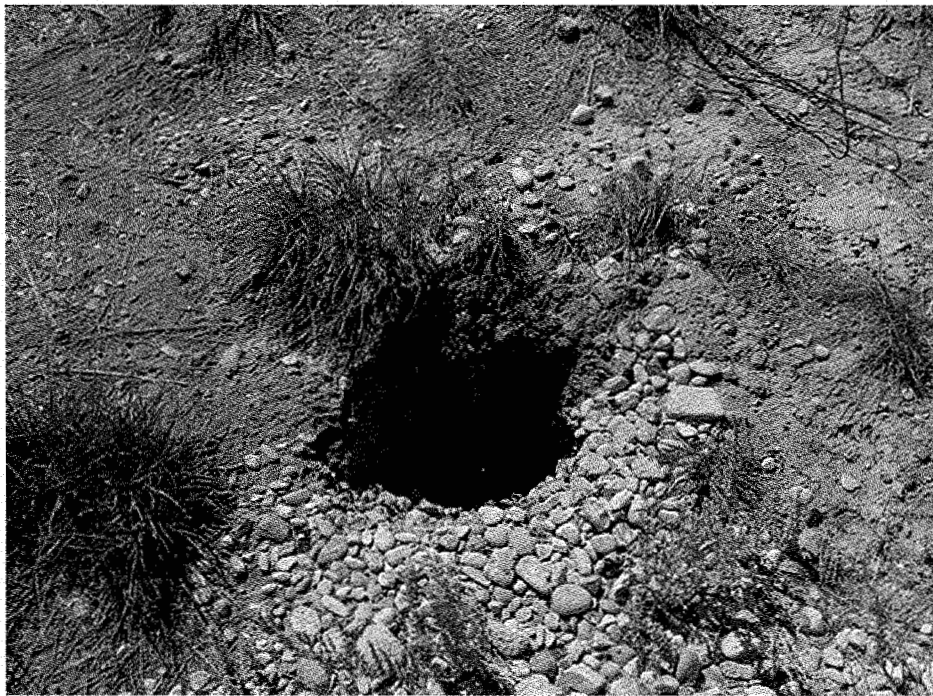
The subsidences found in boreholes at WRRTF-01 and TSF-03 were photographed, and Figure 3 shows subsidence in a borehole at TSF-03. Figures 4 and 5 show boreholes at WRRTF-01.

Site	Signs of Intrusion	Subsidence/Erosion	Signs in Place and Readable	Change from 2001 Inspection
Soil Contamination Area TSF-06 Area B	No intrusion	None	Yes	None
V-Tanks TSF-09 and -18	No intrusion	None	Yes	None
PM2A Tanks Area TSF-26	No intrusion	None	Yes	None
Burn Pits TSF-03/WRRTF-01	No intrusion	Subsidences noted in boreholes at WRRTF-01 and subsidence at TSF-03	Yes	Evidence of minor subsidence in some boreholes at WRRTF-01 and TSF-03

Figure 3. Subsidence in a borehole at TSF-03 (photo taken on May 1, 2002).

Corrective action was completed at WRRTF-01 and TSF-03 on May 30, 2002, when maintenance personnel used heavy equipment to move clean fill from adjacent borrow sources to fill the subsided boreholes and to contour them to match the surrounding area. The repairs were photographed on June 26, 2002, and Figure 6 shows a repaired area at TSF-03. Figure 7 shows a repaired area at WRRTF-01.

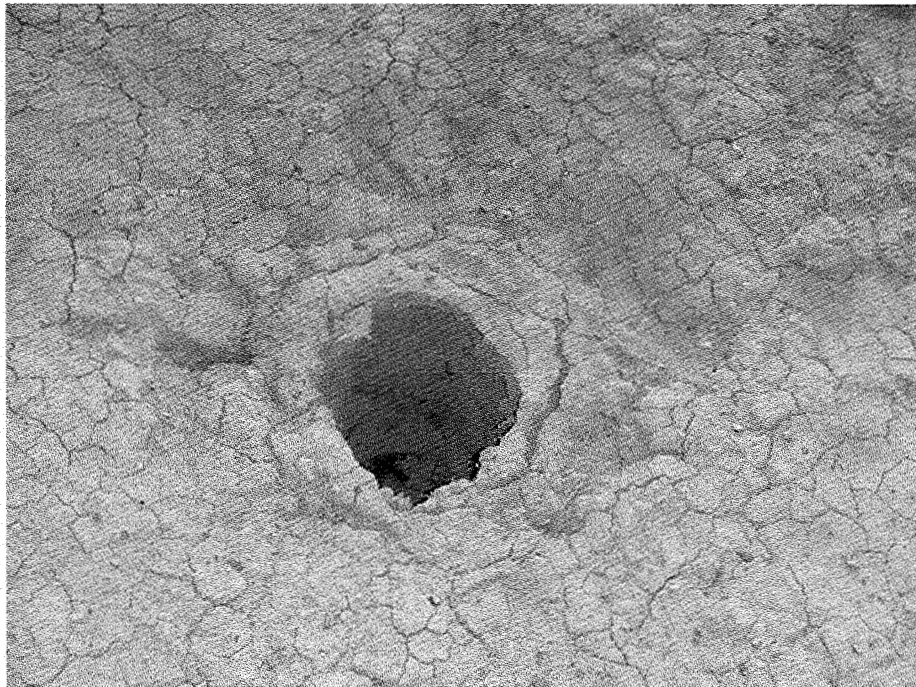
Figure 4. Subsidence in borehole at WRRTF-01 (photo taken May 1, 2002).

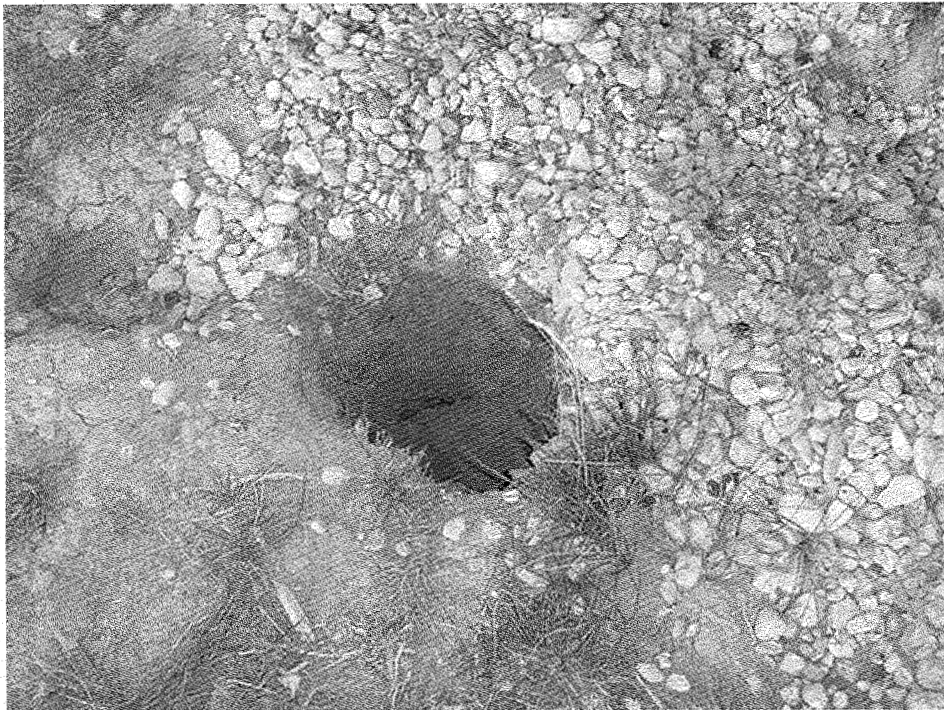
Figure 5. Subsidence, 8-in.diameter and 10 in. deep, at WRRTF-01 (photo taken May 1, 2002).

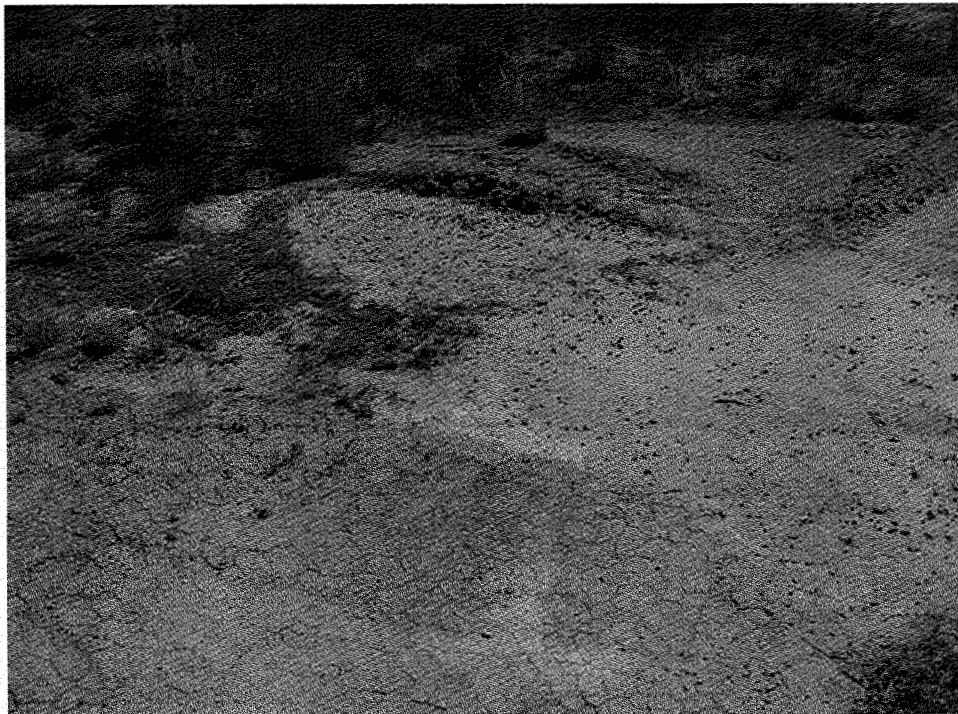
Figure 6. Repaired subsidence at TSF-03 (photo taken June 26, 2002).

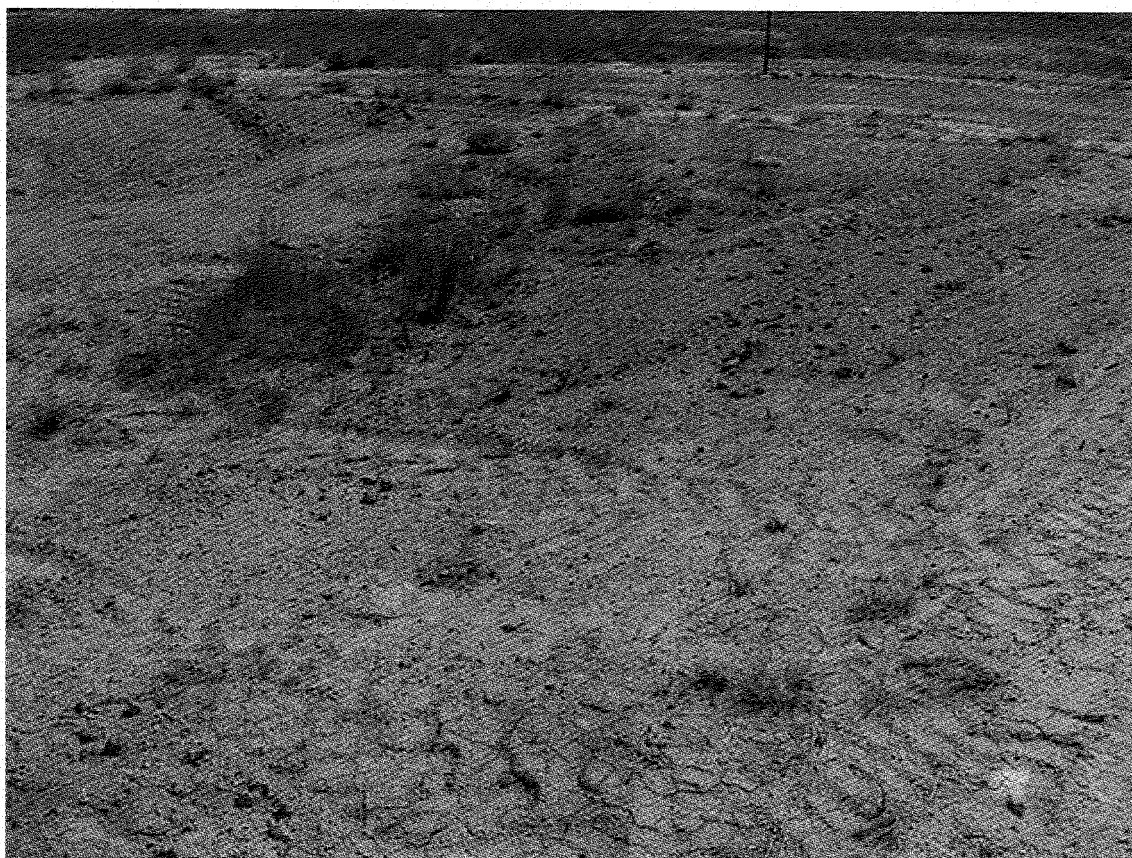
Figure 7. Repaired subsidence at WRRTF-01 (photo taken June 26, 2002).

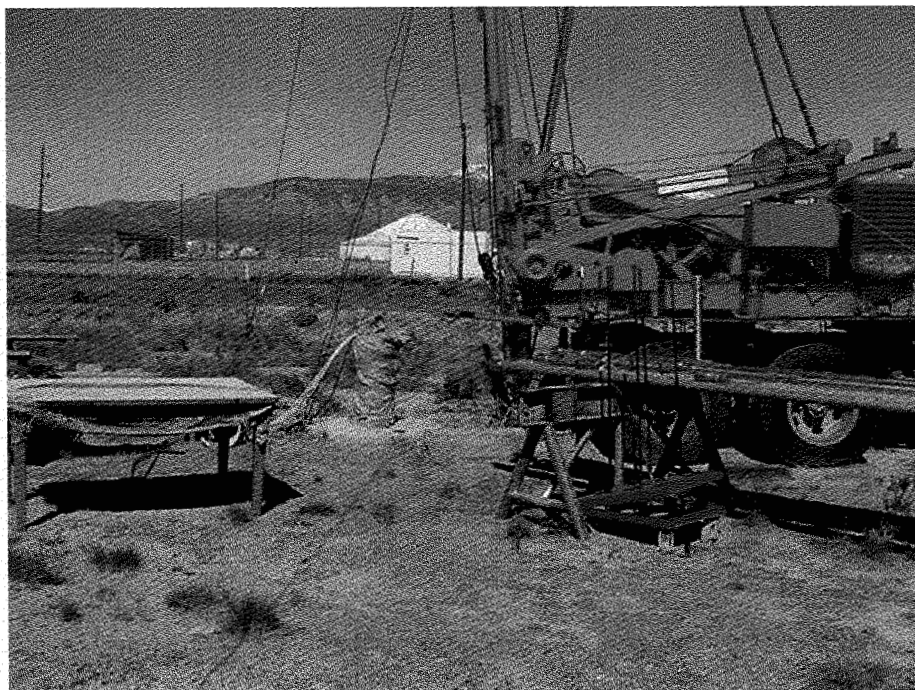
During the inspection, it was noted that the TAN-35 well is completely wrapped in plastic and tape with a drilling rig nearby. The institutional control sign had not been placed at this site, because no representatives of the owner, the University of Idaho, have been present and the well is inaccessible. This condition was consistent with the 2001 inspection.

Figure 8. TAN-35 well on May 1, 2002.

It was noted that University of Idaho personnel visited well site TAN-35 in late May 2002 and cleared the area of their equipment. The wellhead was uncovered, and the drill rig was removed. TAN maintenance then capped and locked the well, and the institutional control sign was placed on the well. This activity results in all of the wellheads at TSF-23 being in compliance with institutional controls. Figures 8 and 9 show the TAN-35 site at the time of the annual inspection and after the cleanup. A complete photo log of the 2002 inspection is maintained in the WAG 1 project files.

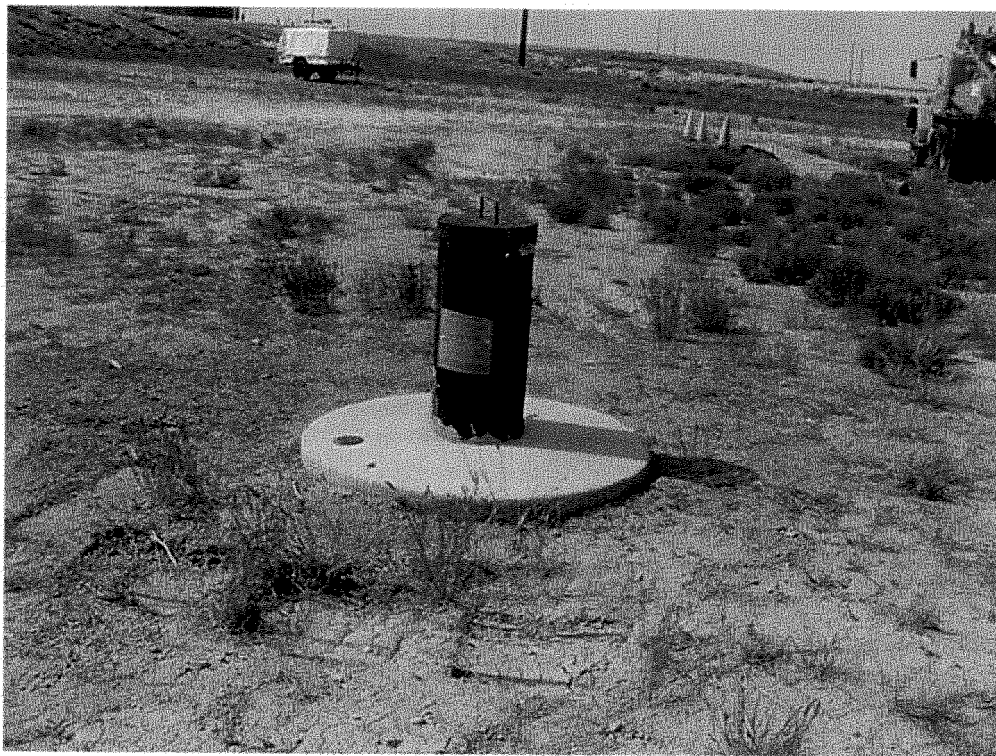
Figure 9. TAN-35 well on June 26, 2002.
